September 12, 2007

Re: 1234 Dorothy Drive  
Aurora, IL 60504

#### **REPORT SUMMARY**

*Pre-Purchase Inspection Performed by  
Joel Dunwell of Dunwell Home Inspections, Inc.  
Illinois License# 450.0001778.*

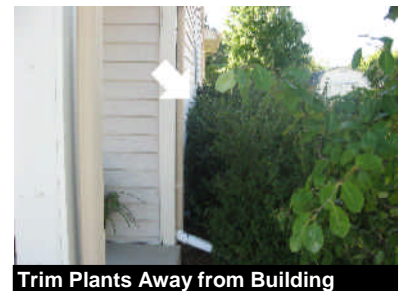
**Attention Needed:** Trim plants away from structure to prevent damage to siding/roof material. Typical maintenance.

Trim Plants Away from Building

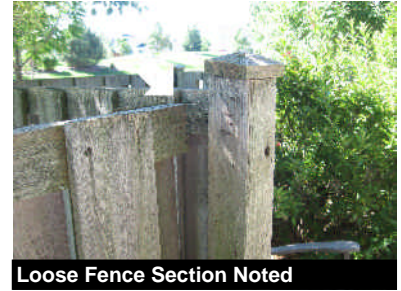
**Attention Needed:** Loose fence section noted  
at the rear of the yard. Minor repair.

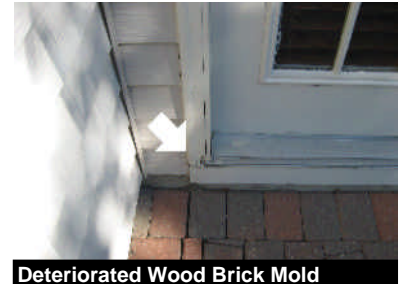
**MATERIAL:** Wood.  
**CONDITION:** **Attention Needed:** Rear patio door brick mold is beginning to deteriorate at the bottom of the door. Repair/Replacement will be needed in the not too distant future.  
 Recommend monitoring.  
 Annual inspections of the wood trim and caulking is recommended as part of typical maintenance.

**Deteriorated Wood Brick Mold**

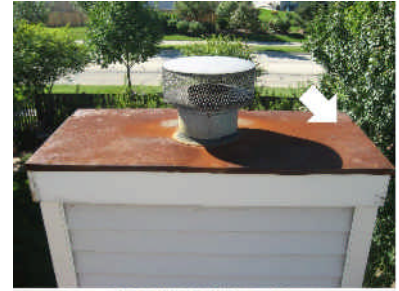
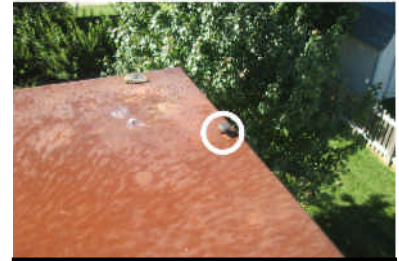
**Note:** Cap is beginning to rust. No visible holes were present at this time.

**Attention Needed:** Exposed nails are present at metal cap.

Seal Exposed Nails

Recommend sealing/caulking nails to prevent moisture intrusion.

Recommend regular monitoring as part of typical maintenance.

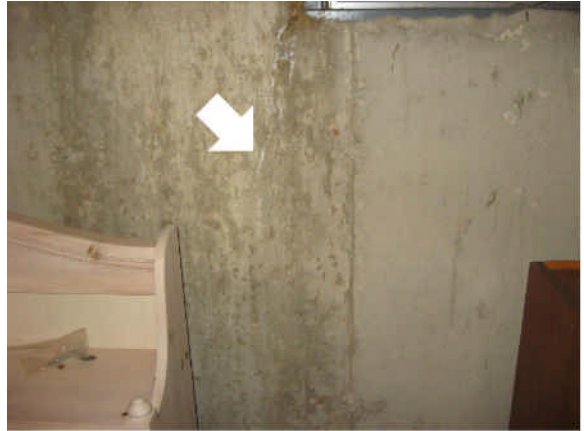
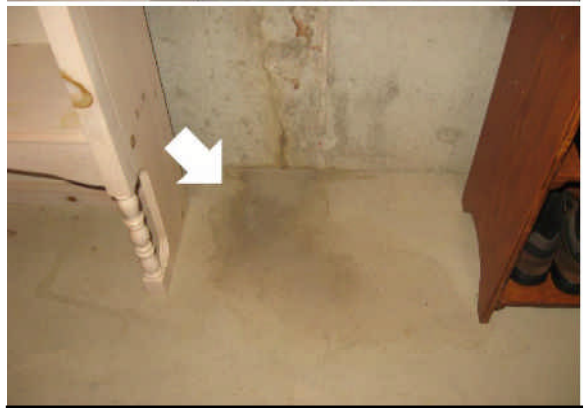
**Action Needed:** Staining was observed: Evidence of past/present water penetration is noted- Viewed at the side basement wall. Recommend sealing crack to prevent future moisture intrusion.

Minor settlement cracks noted, not significant at this time.

**Action Needed:** Staining was observed: Evidence of past/present water penetration is noted- Viewed at the side basement wall.

**Evidence of Past Moisture Seepage**

Recommend sealing crack to prevent future moisture intrusion.

Budget \$350 - \$400 for professional sealing of crack.

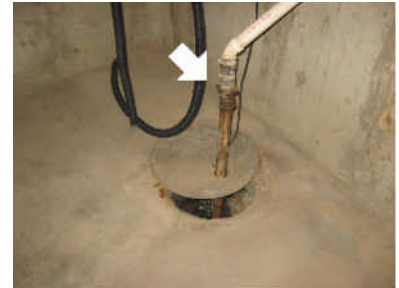
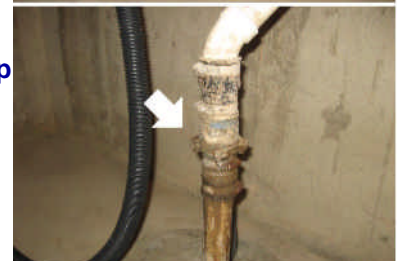
**Action Needed:** Active leak is noted at sump pump discharge line. Noted at the check valve connection. Have a qualified/licensed plumber further evaluate and make repairs.

**Action Needed:** Active leak is noted at sump pump discharge line. Noted at the check valve connection.

Sump Pump & Active Leak

Have a qualified/licensed plumber further evaluate and make repairs.

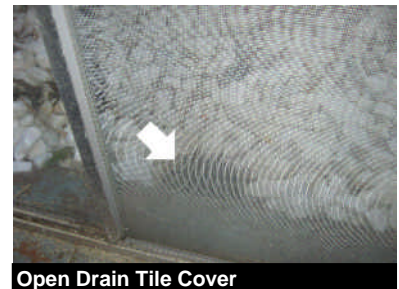
**Attention Needed:** Open drain tile is noted in the basement window well.

Open Drain Tile Cover

Recommend installing cap to prevent vermin and debris from entering.

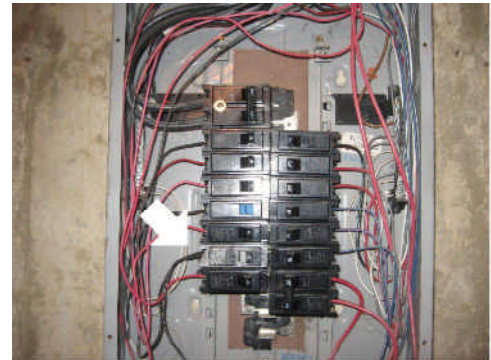
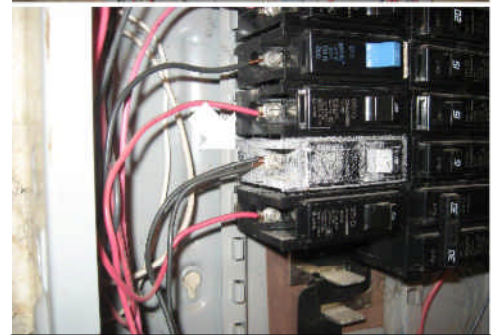
**Action Needed:** Multiple wires are connected to a single lug on a circuit breaker where only one wire should be connected. Improper. Have a licensed electrician evaluate and make repairs.

**Action Needed:** Multiple wires are connected to a single lug on a circuit breaker where only one wire should be connected. Improper.

**Double Tapped Circuit Breaker**

Have a licensed electrician evaluate and make repairs.

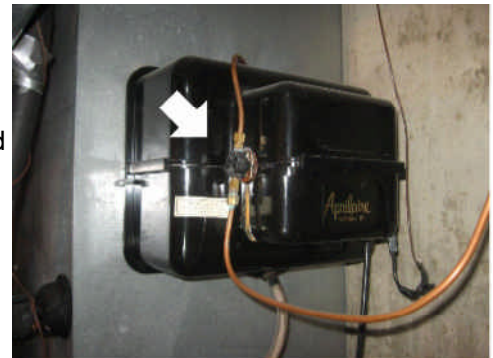
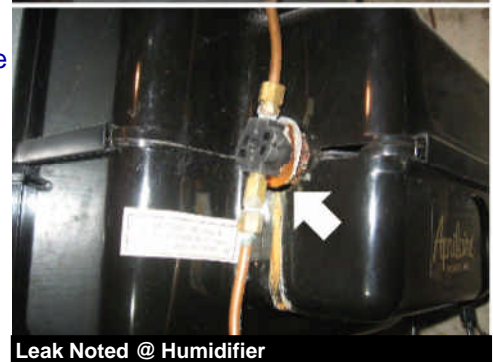
Appears serviceable.  
 Appear serviceable.  
 Recommend changing the filter on a monthly basis to ensure furnace functions properly.  
**Attention Needed:** Active leak is noted at the humidifier. Repair/Replacement will be needed.  
 Have a qualified/licensed heating contractor evaluate and make repairs. A humidifier is installed on the furnace. Humidifiers need regular maintenance to ensure proper working order. Ensure manufacturers manual is present before taking possession of the home.  
 Humidifiers should only be on during the heating season.

Leak Noted @ Humidifier

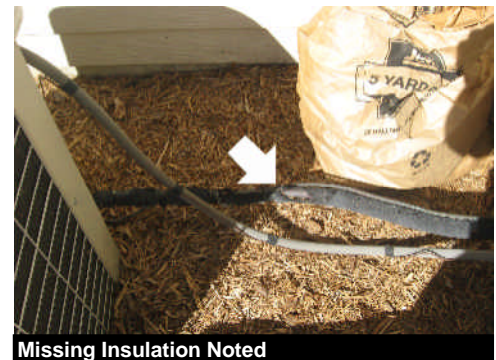
Visible components of the system appear serviceable.  
**Attention Needed:** Some deteriorated insulation is noted at exterior cold refrigerant lines.  
Recommend replacing insulation to prevent condensation from forming.  
Minor repair.

**Missing Insulation Noted**

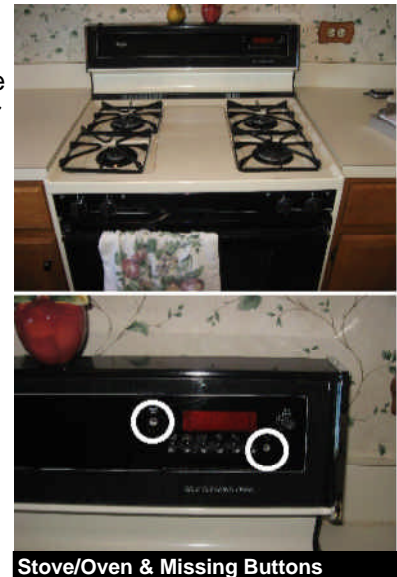
**TYPE/  
CONDITION:** Gas freestanding oven.  
Operational.  
**Note:** Button was needed to turn on and off the oven function. Button was located in the upper cabinet.  
Older model appliance.

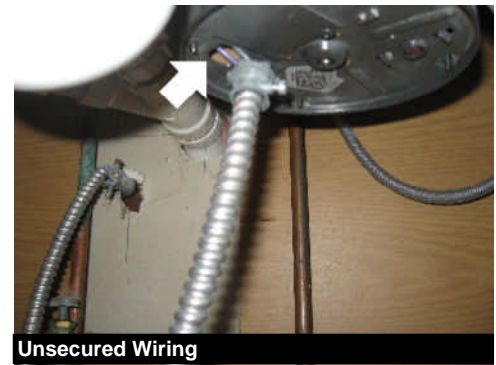
Operational.  
**Attention Needed:** Loose/Unsecured wiring noted at the underside of the disposal.  
Properly secure wiring to prevent damage to wiring.

Unsecured Wiring
